**UNITED STATES ENVIRONMENTAL PROTECTION AGENCY**

**Re: Arconic/Alcoa West Plant – Massena, 45 County Route 42 (Park Ave East)  
EPA Inspection August 30 to September 1, 2017  
SPDES Permit No: NY0001732**

## Water Compliance Inspection Report

<b>Compliance Evaluation Inspection – Massena Operations – Alcoa/Arconic West Plant</b>	
<b>Inspection Date:</b> August 30, 2017 to September 1, 2017 <b>Inspection Time:</b>	<b>EPA Representatives:</b> Murray Lantner, P.E. Environmental Engineer, USEPA Region 2, (212) 637-3976, <a href="mailto:lantner.murray@epa.gov">lantner.murray@epa.gov</a> Peter Bahor, Enforcement Officer, USEPA-HQ, (202) 564-7029, <a href="mailto:bahor.peter@epa.gov">bahor.peter@epa.gov</a>  <b>New York State Department of Environmental Conservation, Region 6 Representative</b> David Rarick, P.E. Environmental Engineer II, 317 Washington Street, Watertown, NY 13601 (315) 785-2513 (office), <a href="mailto:david.rarick@dec.ny.gov">david.rarick@dec.ny.gov</a>
<b>On-Site Arconic or Alcoa Representatives:</b> Tim Long – (315) 764-4914 (office), (315) 842-1783 (cell) – <a href="mailto:Tim.Long@arconic.com">Tim.Long@arconic.com</a> Todd Furnia (315) 764-4916 (office) (315)

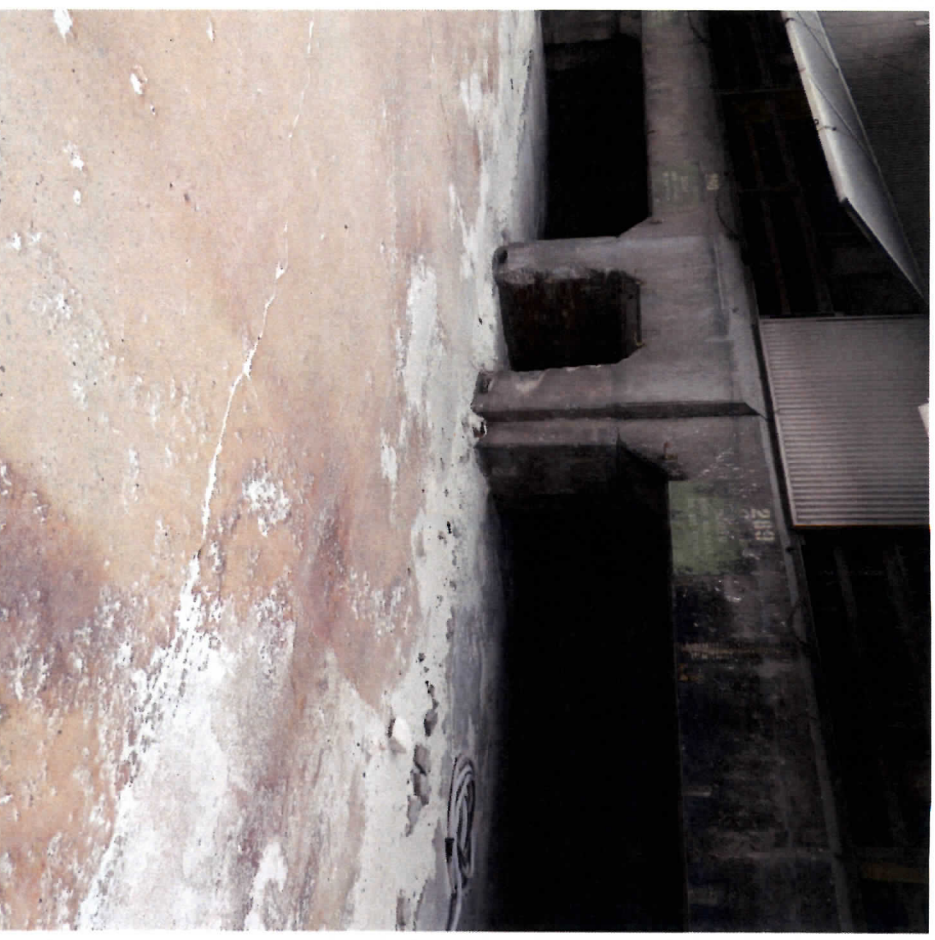
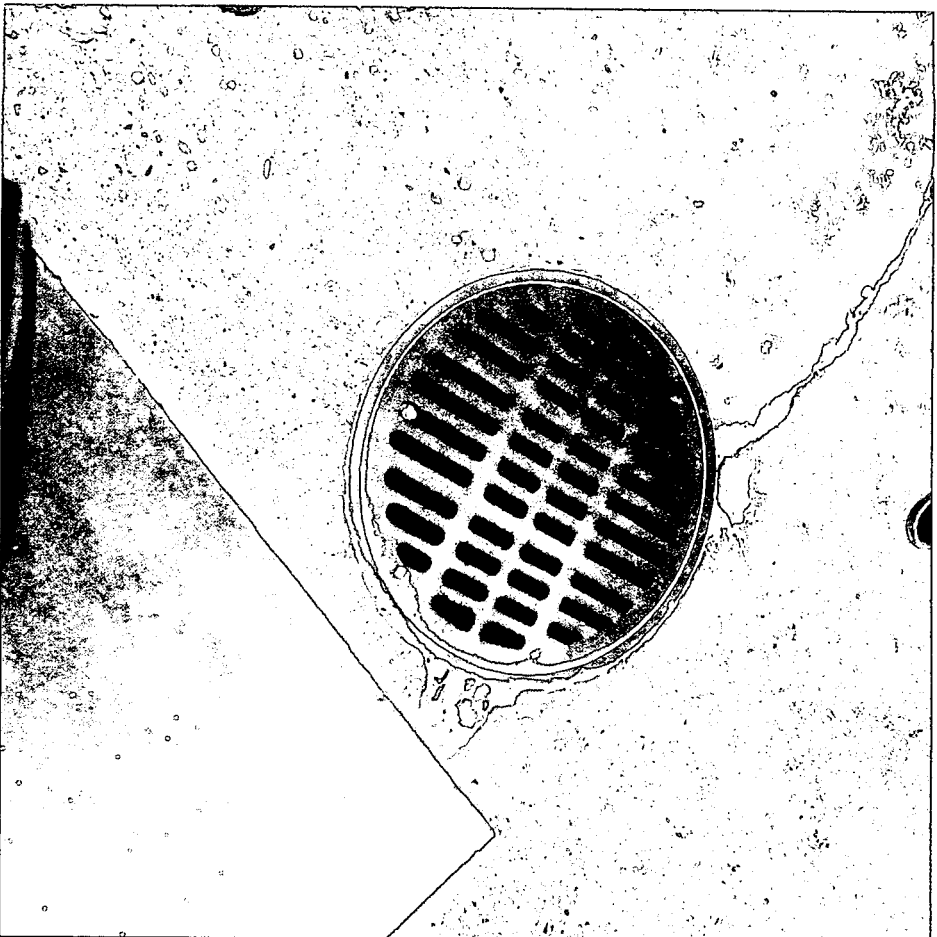
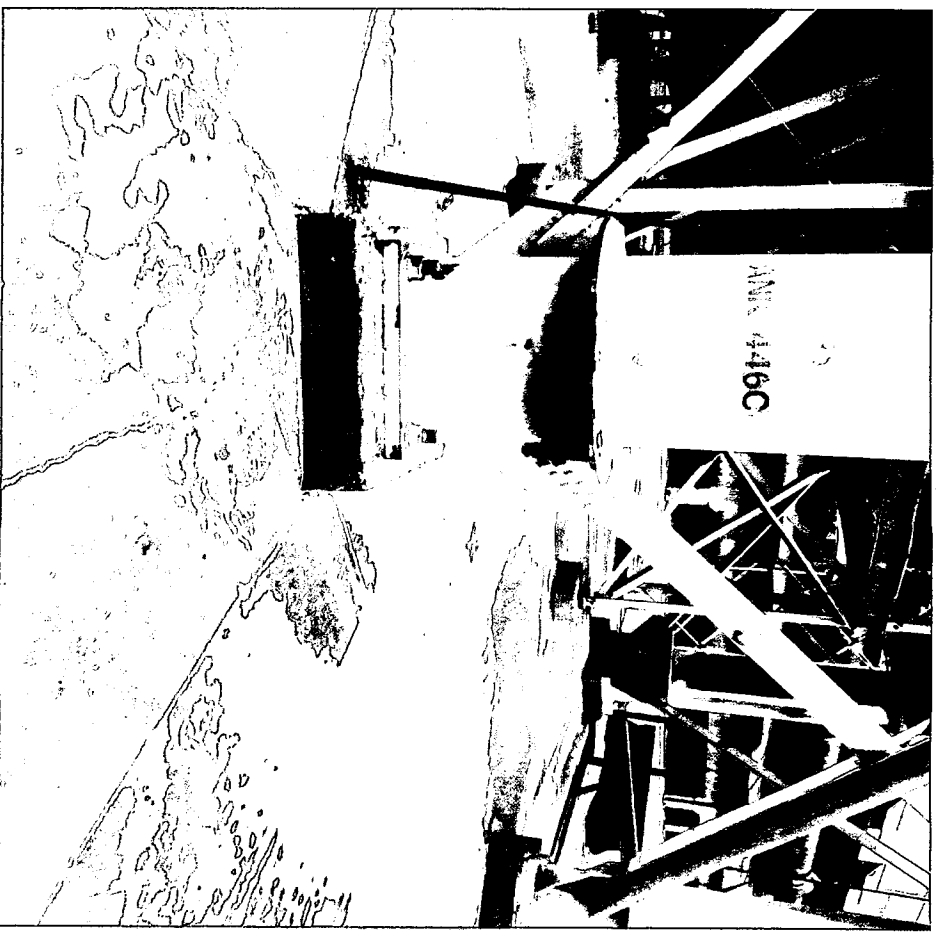
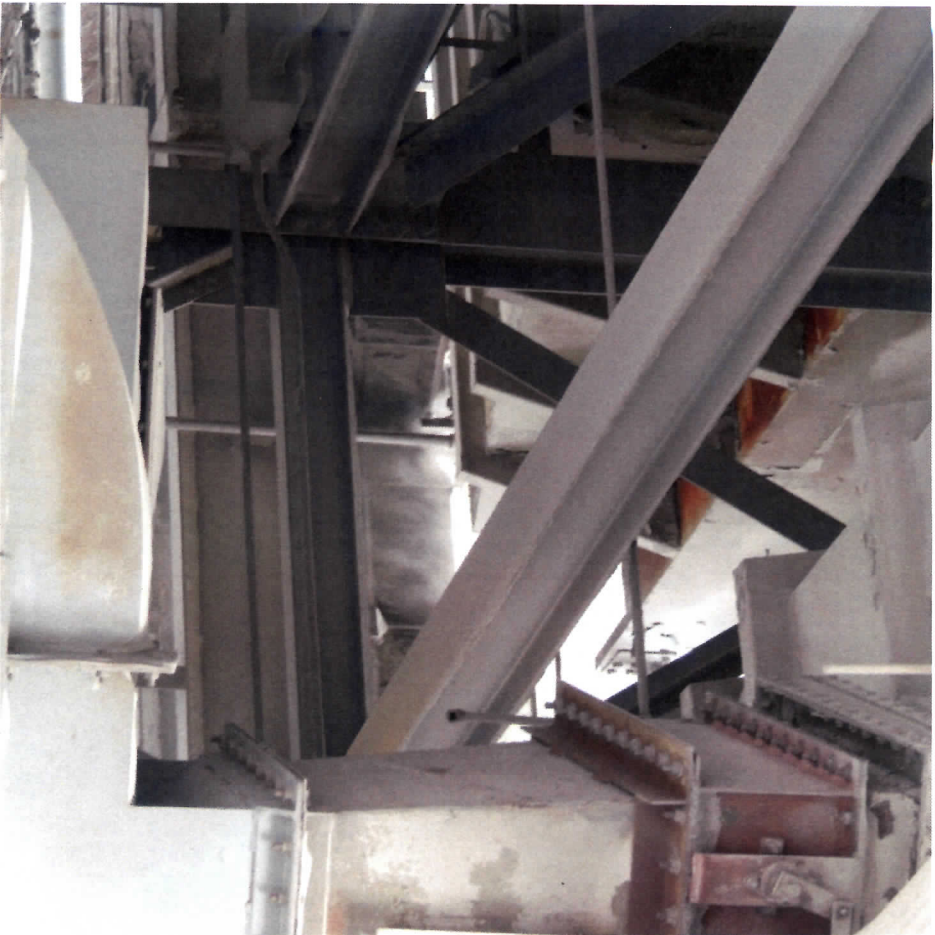
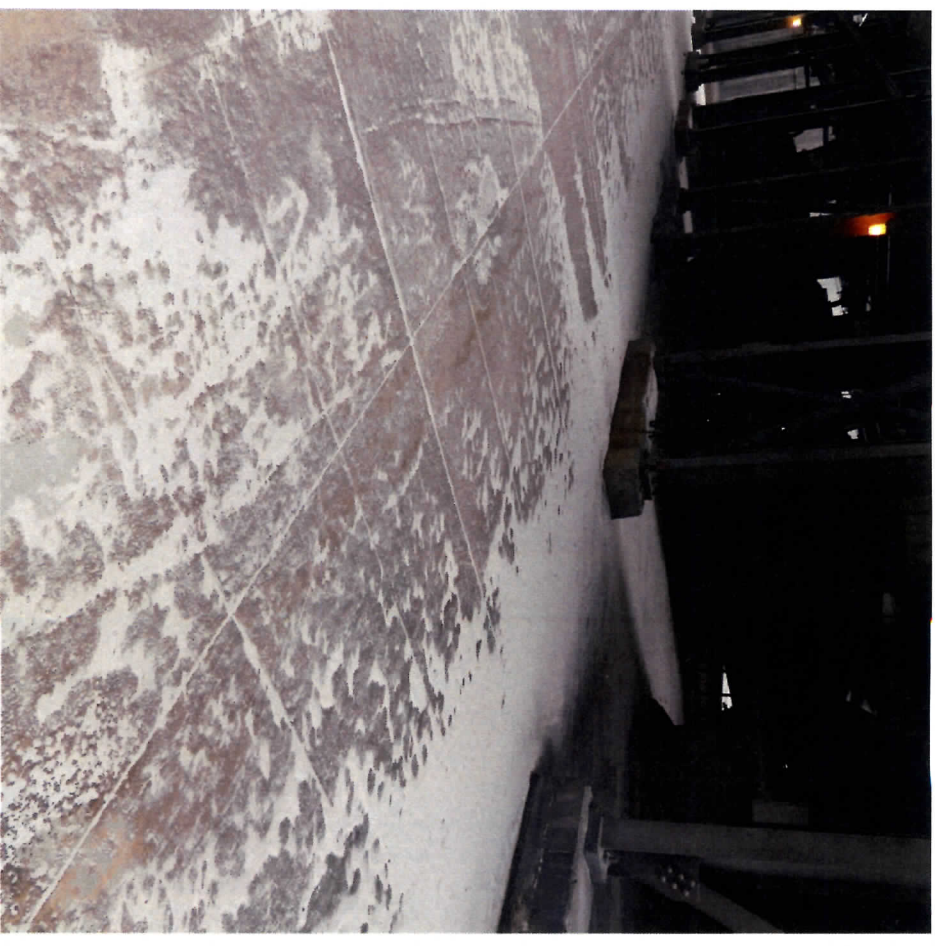
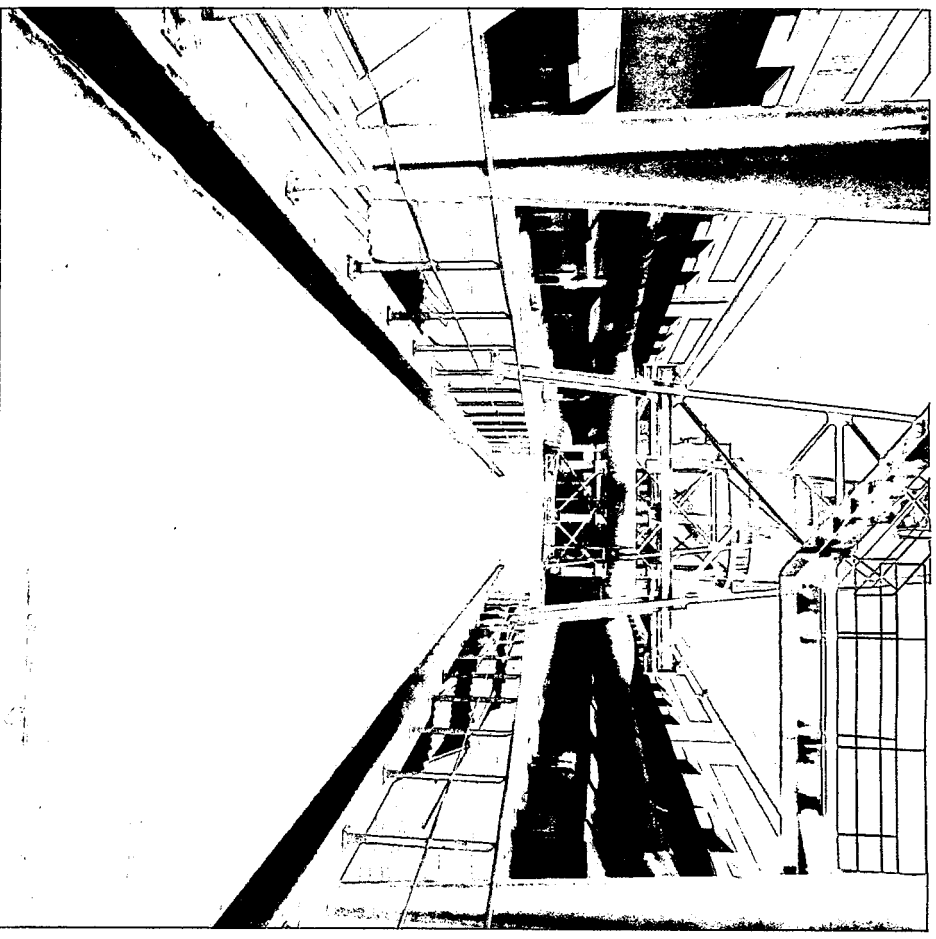
8. During the inspection, we also visited the pot line area owned by Alcoa, but ultimately discharges under the Arconic SPDES Permit. As shown in photos 916 to 924 there was Alumina dust around stormwater inlets and in many places in the yard due to leaks of

alumina from leaking air slides, air lifts and other sources. The Best Management Practices Plan portion of the Permit and the BMP Plan for the facility does require good housekeeping and preventative maintenance for this area. The Area III BMP Checklist in house inspection dated July 24, 2017 identified poor housekeeping in Area III potline courtyard area. And also identified that stormwater inlet controls (drain pyramids) were installed on some inlets. It did also identify numerous leaks in the alumina conveyance system. Similar findings were made in the June 28, 2017 Area III BMP Checklist. (Attachment 4)

DSCN4916 – Alumina Dust near pot line at the southern end of Alcoa courtyard

DSCN4917 – stormwater inlet at pot line – where stormwater runoff containing Alumina could flow into.

DSCN4918 – Alumina dust on ground at Alcoa pot line.

DSCN4919 – reacted alumina on ground below air lift

DSCN4920 - reacted alumina on ground below air lift

DSCN4921 – air slide leakage - alumina dust coming from building

DSCN4922 – alumina dust on ground of courtyard

DSCN4923 – Alumina dust around stormwater inlet.

DSCN4924 – Alcoa pot line courtyard – Alumina Dust Seen

Alcoa representatives said that they sweep the courtyard twice per week, but sweeper had been broken for 2 days and said that stormwater inlets are vactored once per quarter. Improved housekeeping and repair of leaking equipment is needed in this area.

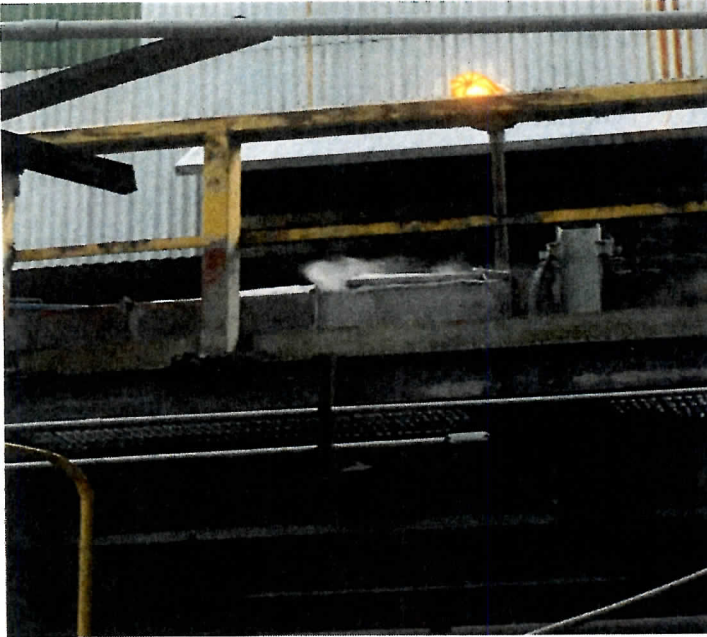
Drain pyramids' have been installed in some locations

**Numerous leaks in the alumina conveyance system**

**Is there a plan to complete all courtyards?**

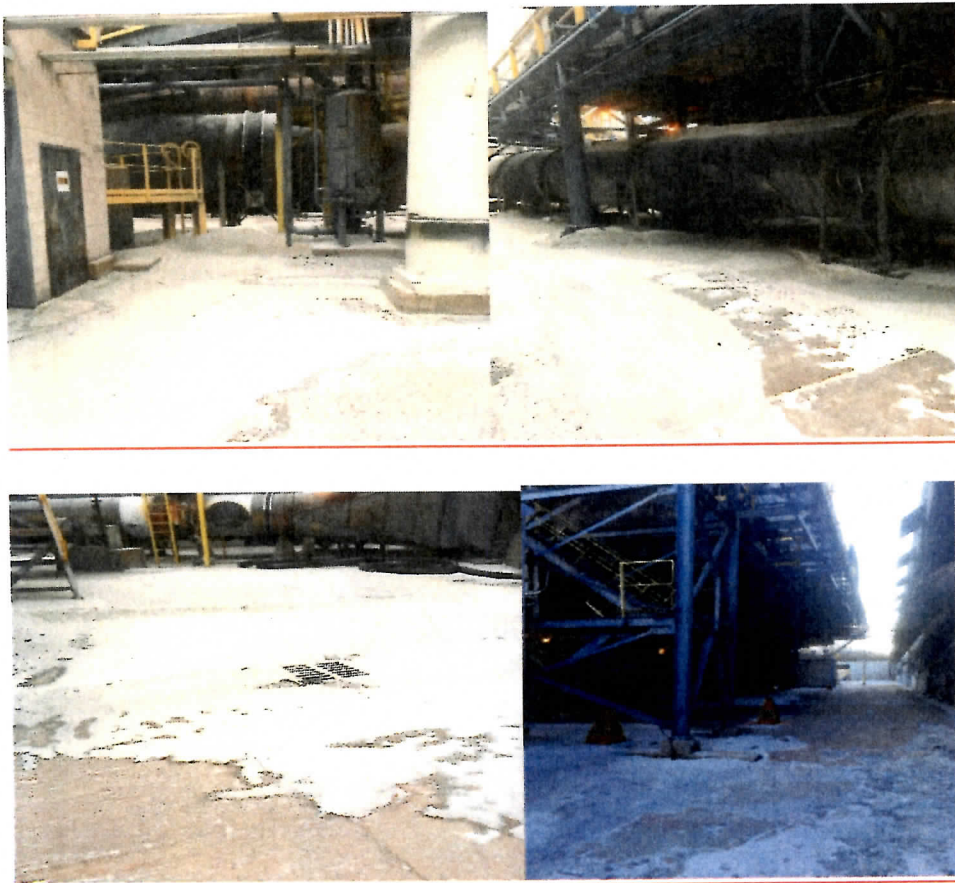
**These photos are typical of all three court yards, material is making it to drain...**

**Drain pyramids' have been installed in some locations**

**Is there a plan to complete all courtyards?**
